The roof garden of the Comturey Restaurant offers visitors an overwhelming view of Lake Constance.

Area: ca. 1.500 m<sup>2</sup>  
 Construction Year: 2014  
 Client:  
 Mainau GmbH, Insel Mainau  
 Architects:  
 Hein Architekten, Bregenz  
 Steinmann Landschaftsarchitektur,  
 Winterthur  
 Landscape Design:  
 Planning Department of the Mainau GmbH  
 Contractor:  
 Schellhammer & Söhne GmbH,  
 Mühlhausen-Ehingen  
 Coordinates:  
 47°42'18.03"N 9°12'2.15"E

### Conception

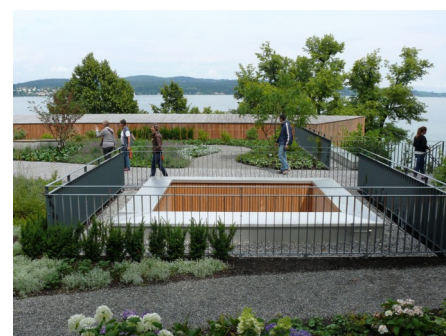
Custom-made guardrails were installed on the ZinCo Guardrail Bases all along the atriums and any other edges.

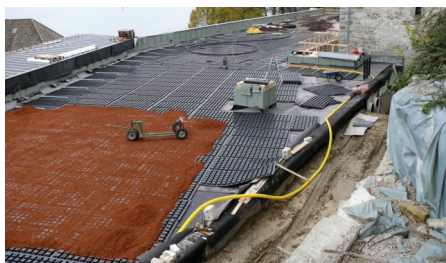
The drainage and water storage element Floradrain® FD 60 makes sure that the overall roof area is being drained properly via its two narrow edges.

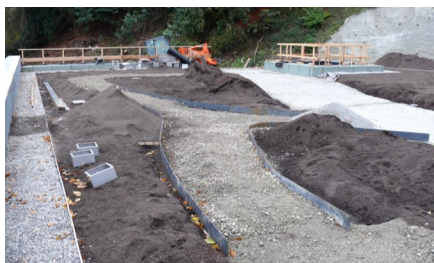
Paths and planting areas during the landscaping works.

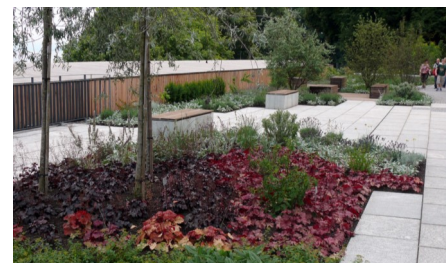
The completed green roof about three months after the opening.
